ROCK STRIKE TESTING OF TRANSPARENT ARMOR

David N. Hansen, Ph.D. Ashley Wagner

GVSS Paper NLE-01v2

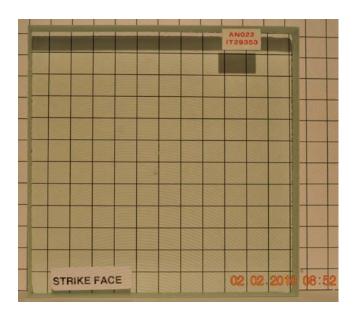
Photograph 1. Minimal Damage at 135 f/s, Ranked 1.

There is only a shadow of a small crush in this photo. Actual speed was 135 fps. 130-AN038 is ranked 3, NCC; and is shown below:

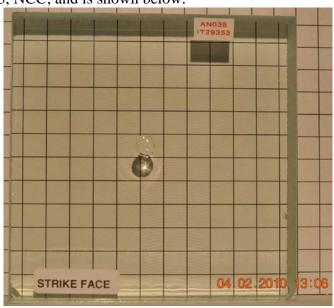
Photograph 2. Minor Damage at 129 f/s.

Note that the chip is decidedly larger despite the actual speed being 129 fps. In the next specimen the recorded speed is the same 129 fps. Notice however that the damage is greater. Not only is there a significant amount of crush, but there is also a group of radial cracks. 130-AN045 is ranked 5, LCR; and is shown below:

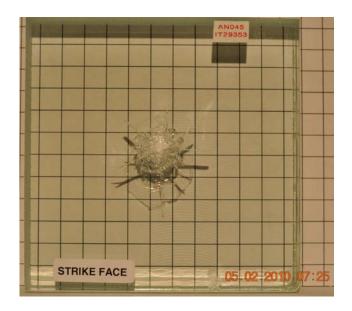
Photograph 3. Heavy but not Major Damage at 129 f/s.
